INVESTIGATION OF THE PREPAREDNESS PROGRAM

REPORT BY
PREPAREDNESS INVESTIGATING
SUBCOMMITTEE
OF THE
COMMITTEE ON ARMED SERVICES
UNITED STATES SENATE

ON
THE COLLAPSE OF TEXAS TOWER NO. 4

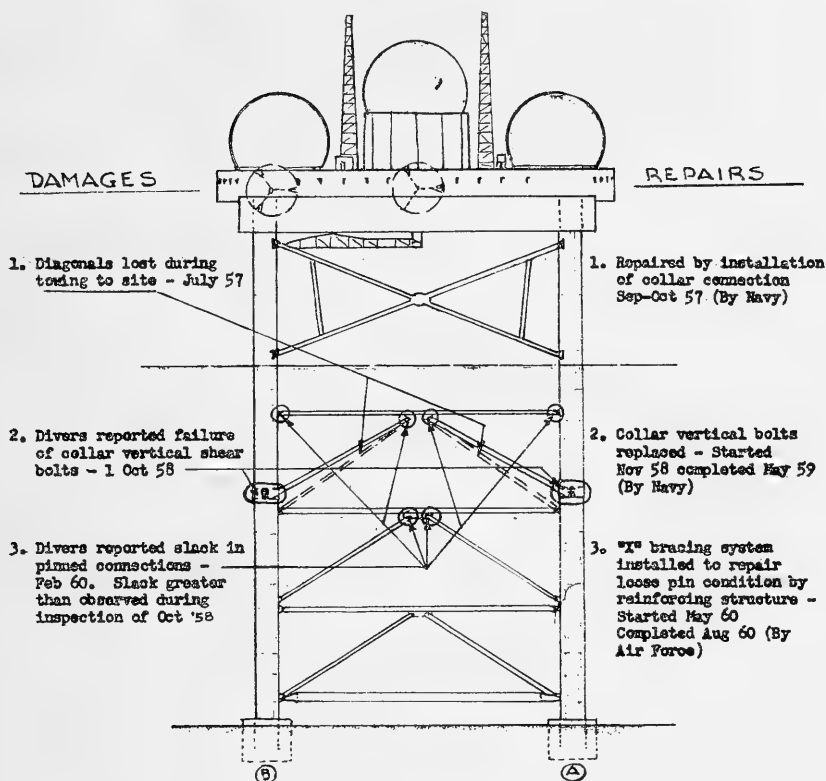
TEXAS TOWER No. 4
 HISTORY OF DAMAGES AND REPAIRS
 2 NOV. 57 TO 12 SEP 60

For a more graphic illustration of the condition of the tower, there is reproduced on p. 25, a schematic diagram depicting the locations of the loose pins and worn connections.

Loose pins and worn connections became a cause for considerable concern. On March 1, 1960, the Engineering Section of the 551st Aircraft Early Warning and Control Wing at Otis Air Force Base telegraphed the 26th Air Division in Syracuse, N.Y., stating in substance that the 4604th Support Squadron had notified the 551st AEW&C wing of excessive sway in the tower on January 20, 1960; that diver inspection in early February disclosed that pins had loosened from $\frac{1}{8}$ inch tolerance to as much as 1 inch in some cases; that this prompted a meeting with the design engineers, Moran, Proctor, Mueser & Rutledge, on February 25, who recommended the installation of abovewater bracing; that such bracing would cost from \$400,000 to \$500,000; and that these repairs must be accomplished on an emergency basis not later than August 1, 1960.

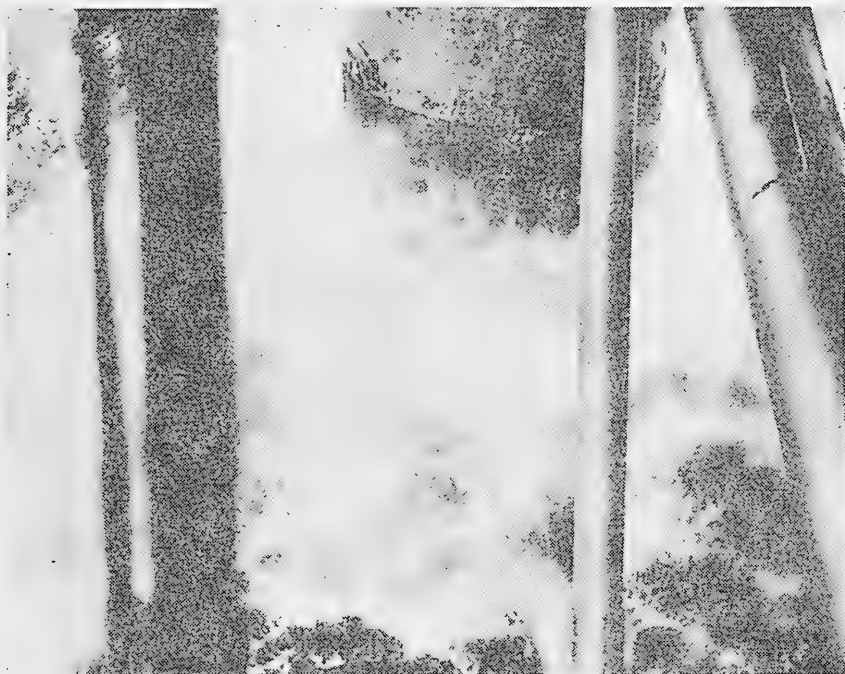
Wave action against above-water X-bracing.

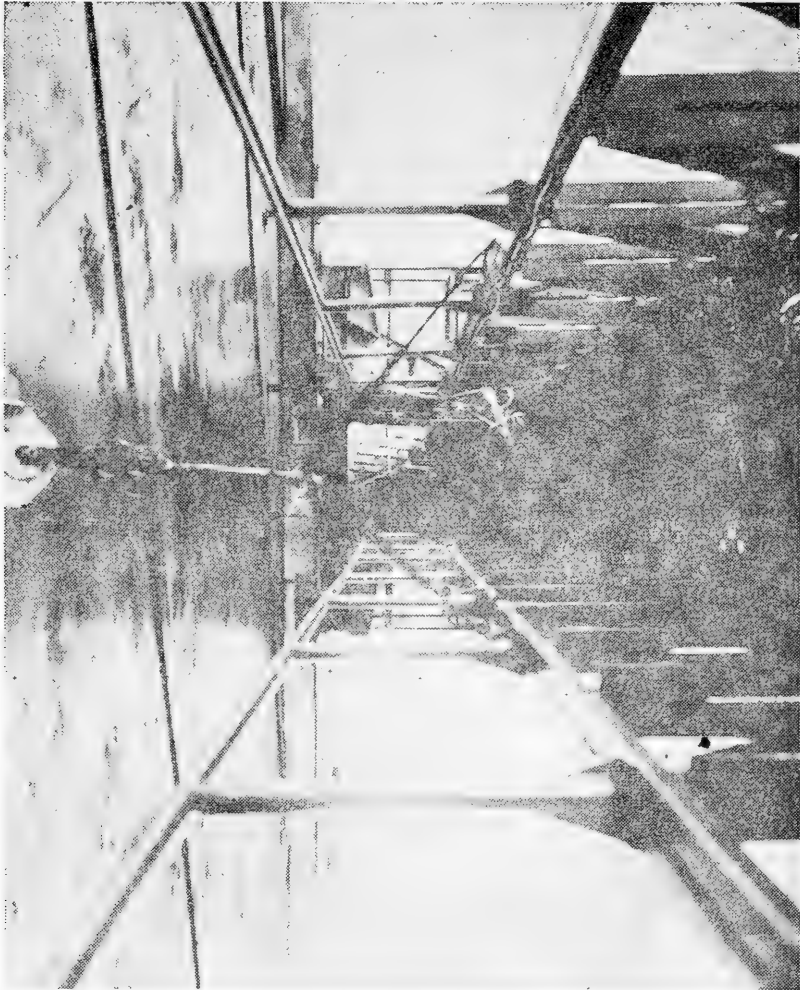
The "flying bridge" or rotating maintenance scaffold suspended beneath the tower had been torn loose and had to be repaired before divers could ascertain the damage to the underwater foundation. For graphic portrayal of damage to the "flying bridge," a photograph showing it against the C leg is reproduced.

Damage to the "Flying Bridge"

J. Rich Steers, Inc., the original builders under contract with the Air Force, completed repair to the "flying bridge" on November 1, 1960, and subsequent inspections revealed the following damage:

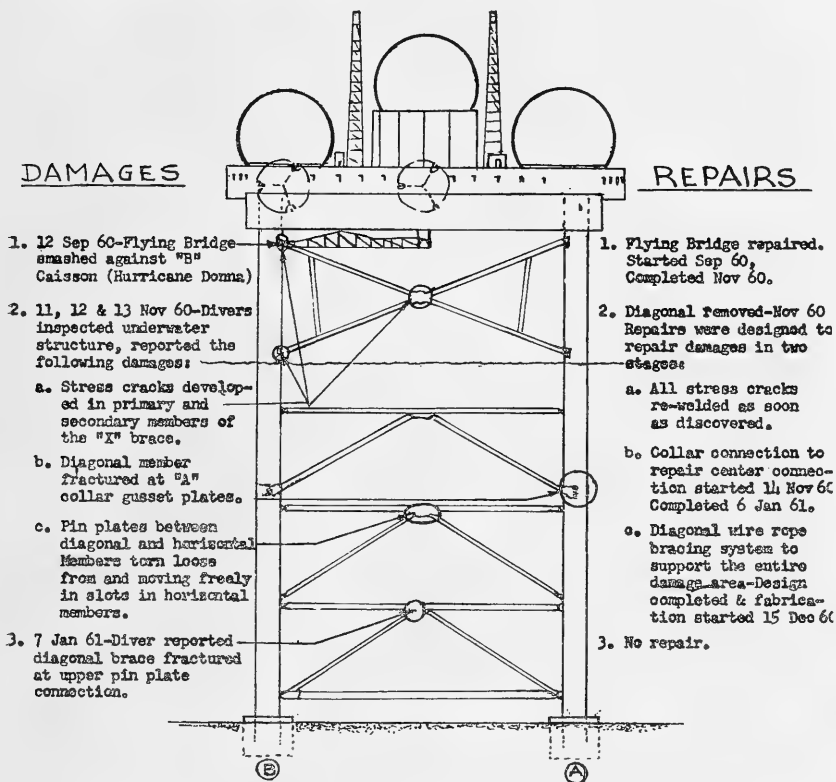
TEXAS TOWER NO. 4

(a) The above-water X bracing was cracked and fractured in its primary and secondary members.

(b) The upper tier A diagonal was fractured.

(c) The two diagonals in the second tier of bracing at the midpoint of the horizontal at elevation -75 feet had torn loose from their attachment and were moving freely. These damages were all on the A-B side.

There is reproduced below a schematic diagram illustrating this damage with the exception that at this time the lowest diagonal brace, shown as being fractured, actually was intact.

HISTORY OF DAMAGES AND REPAIRS
12 SEP 60 TO 7 JAN 61

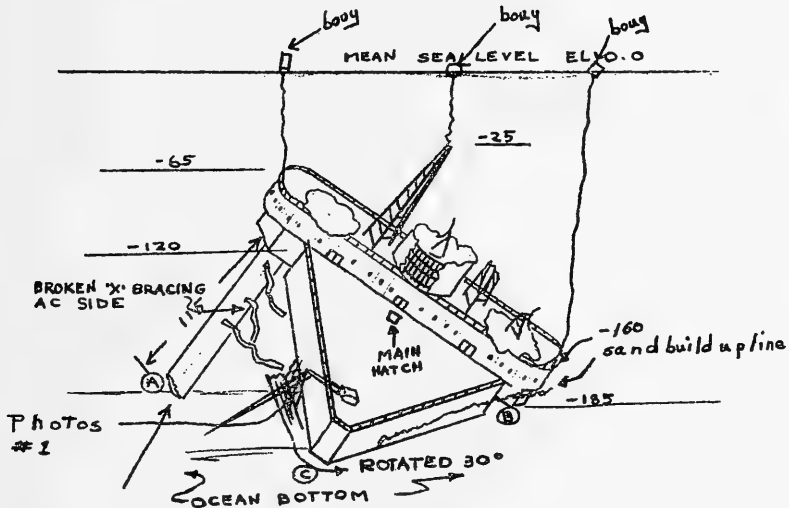
length of remaining section of (A) Computed to be 115'
 upper deck railing carried away
 all windows fractured or broken out
 all hatches and doors carried away
 center radome shell 50% carried away
 center radar antennae down on main
 deck hatch
 2 modulators nearly intact
 BC side wire safety net carried
 away

TEXAS TOWER #4
 CONFIGURATION OF WRECKAGE
 AS INDICATED BY DIVERS
 REPORTS AS OF 28 JAN 61
 ISOMETRIC VIEW FROM 'C' CORNER
 (LOOKING WEST)

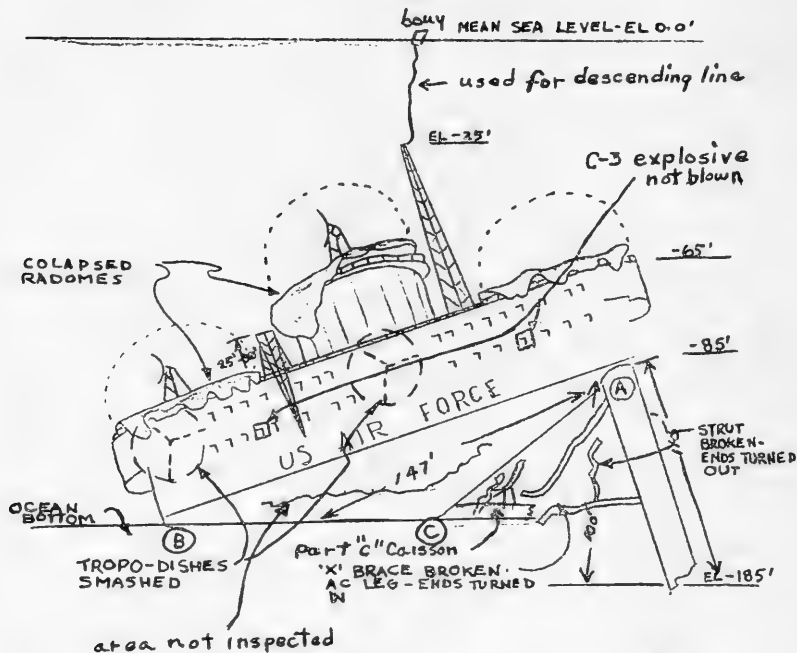
TEXAS TOWER #4

Must be additional sections caissons and bracing underneath Tower, assisting "A" caisson in holding platform off bottom,
